**Knopp House, 4608 Streetsboro Road,
Richfield, OH**

**Knopp House,
4608 Streetsboro, Richfield, OH**

An building analysis by the
Cleveland Restoration Society
February, 2012

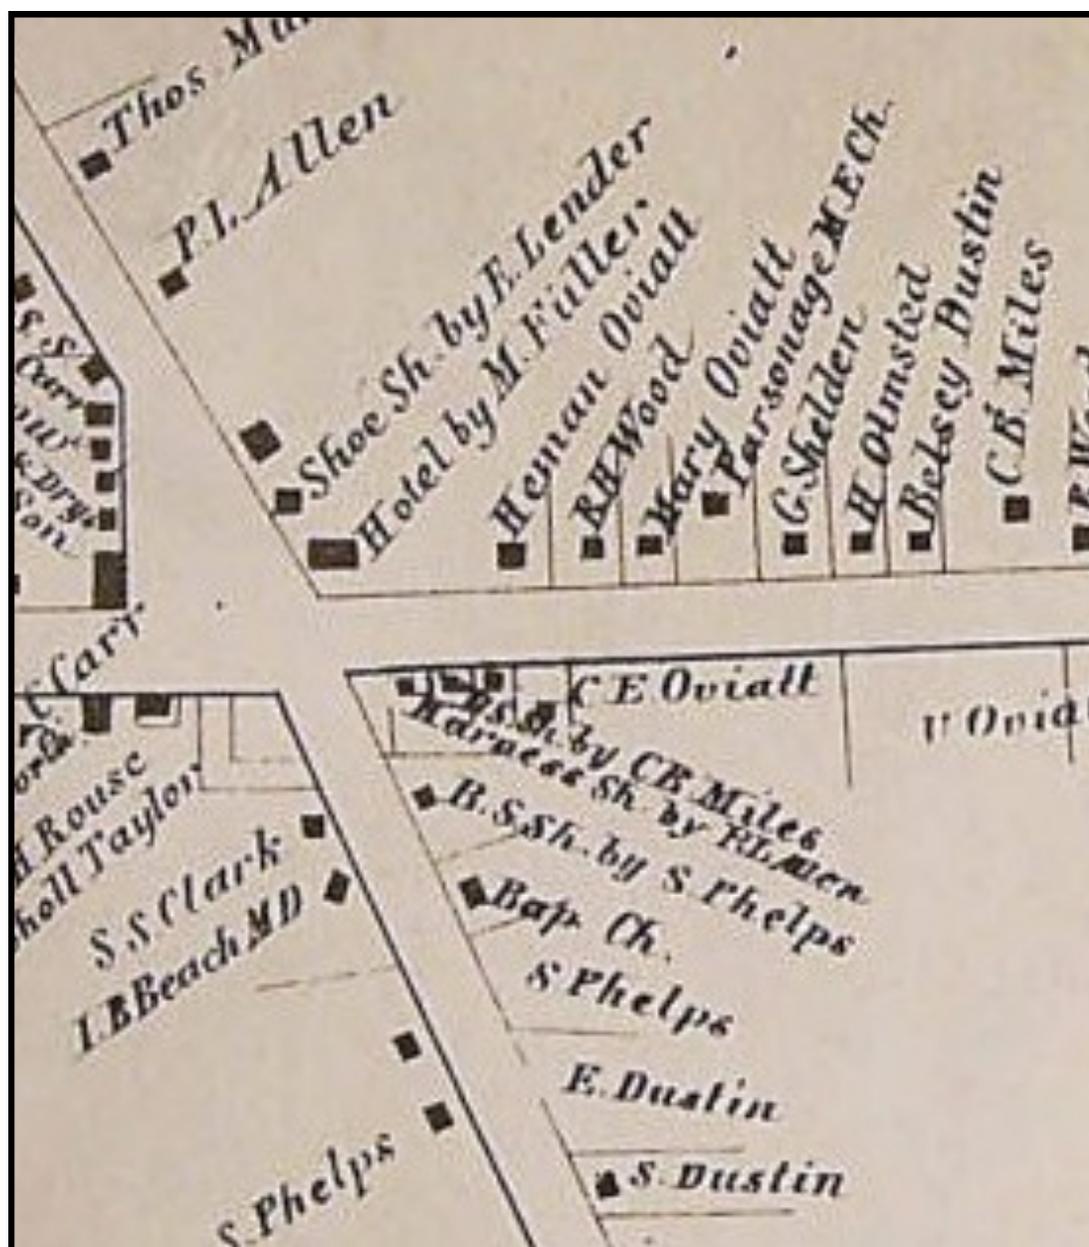
The Map of Summit County, by Hosea Paul, Civil Engineer and Surveyor (Philadelphia, 1856) confirms that the Knopp House was constructed prior to 1856, as it is shown. It appears next to the blacksmith shop of C.B. Miles, but is unlabeled.

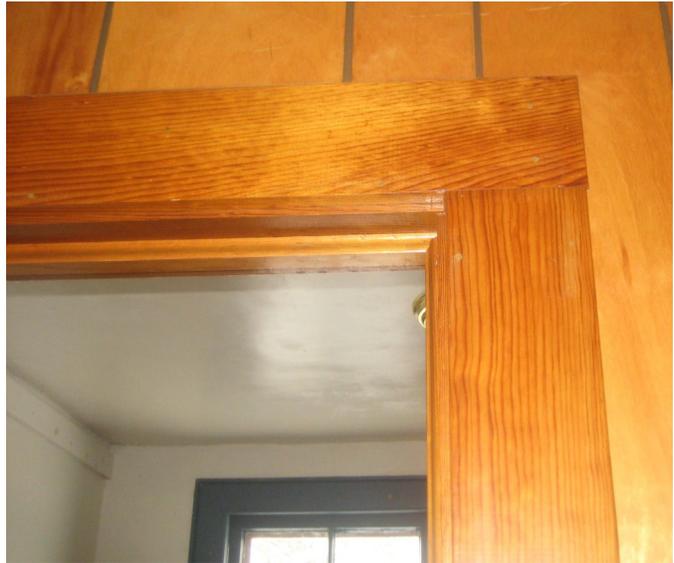
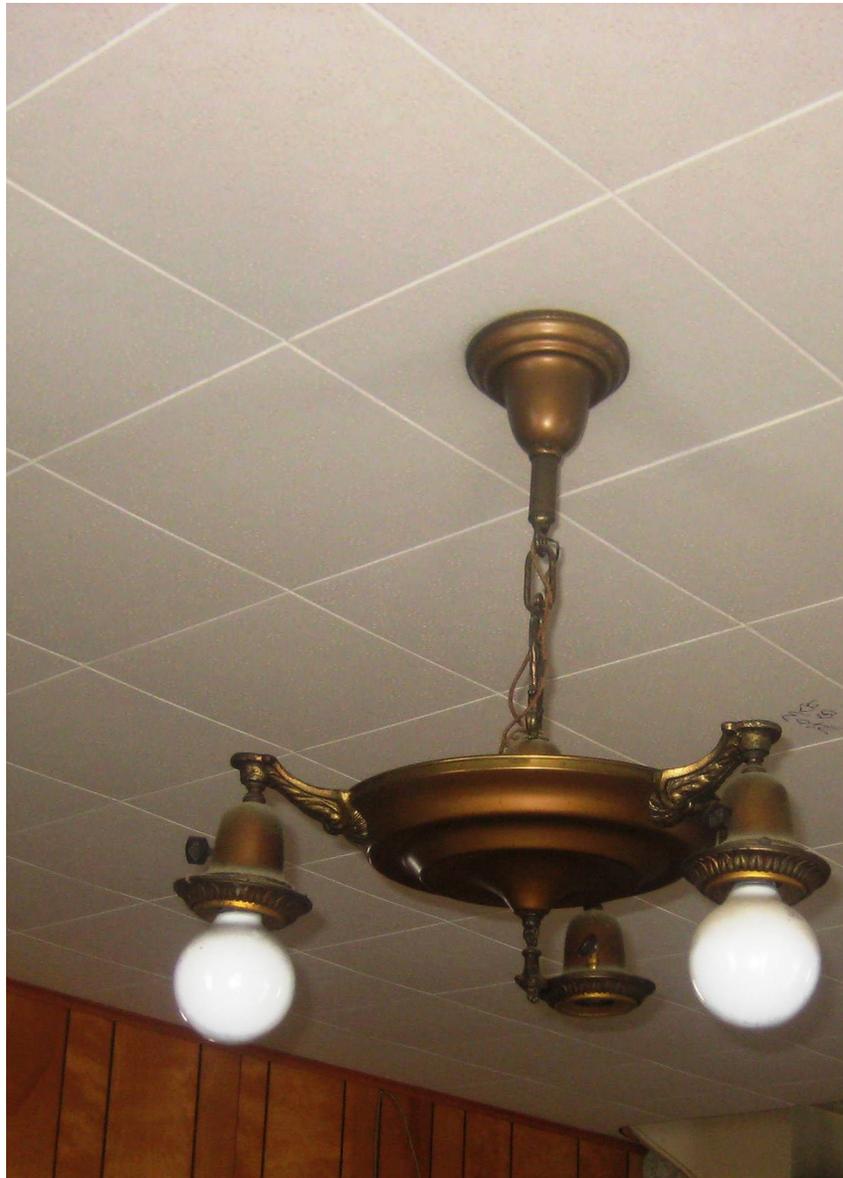
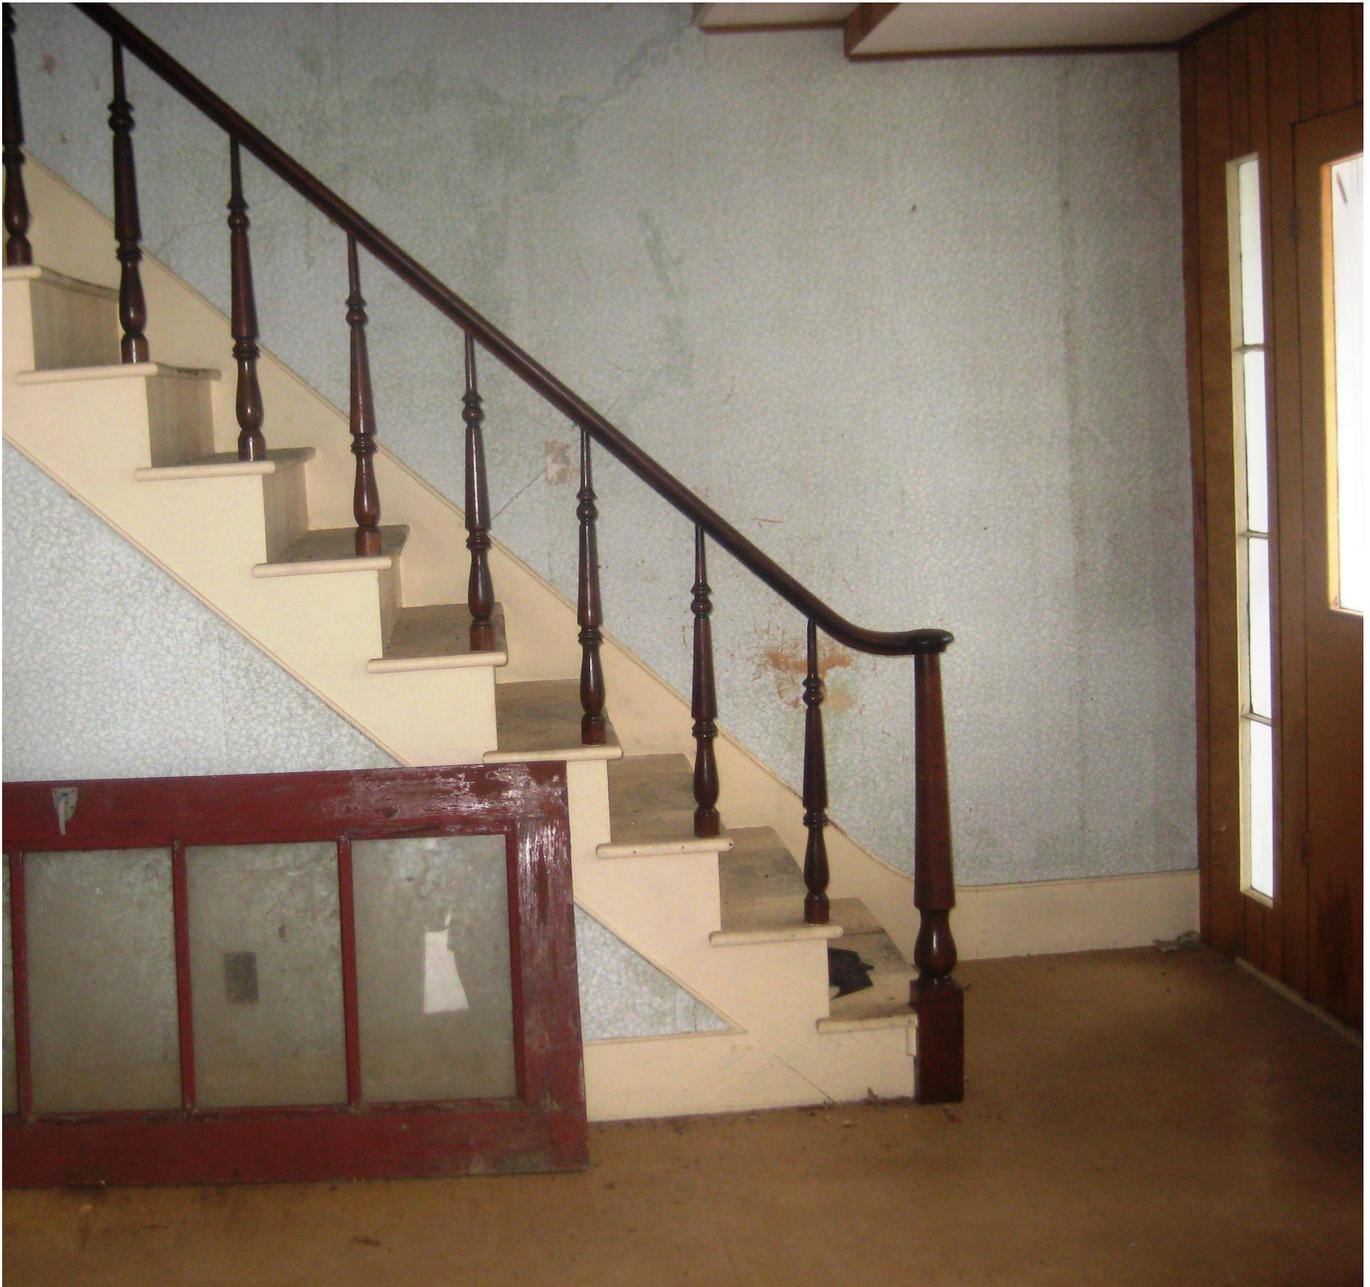
While much of the interior of the first floor of the Knopp House has been covered in finishes of the late 20th Century (wood paneling and vinyl flooring), there is still much historic material left, including a beautiful staircase of the 1850s and woodwork and light fixtures of the early 20th Century. The National Park Service considers these features that are fifty years old or older to be historic or to have gained historic significance. *The Secretary of the Interior's Standards for the Treatment of Historic Properties* says in Standard 4: *Changes to a property that have acquired historic significance in their own right will be retained and preserved.* Thus, the vinyl flooring and wood paneling has not attained historic significance

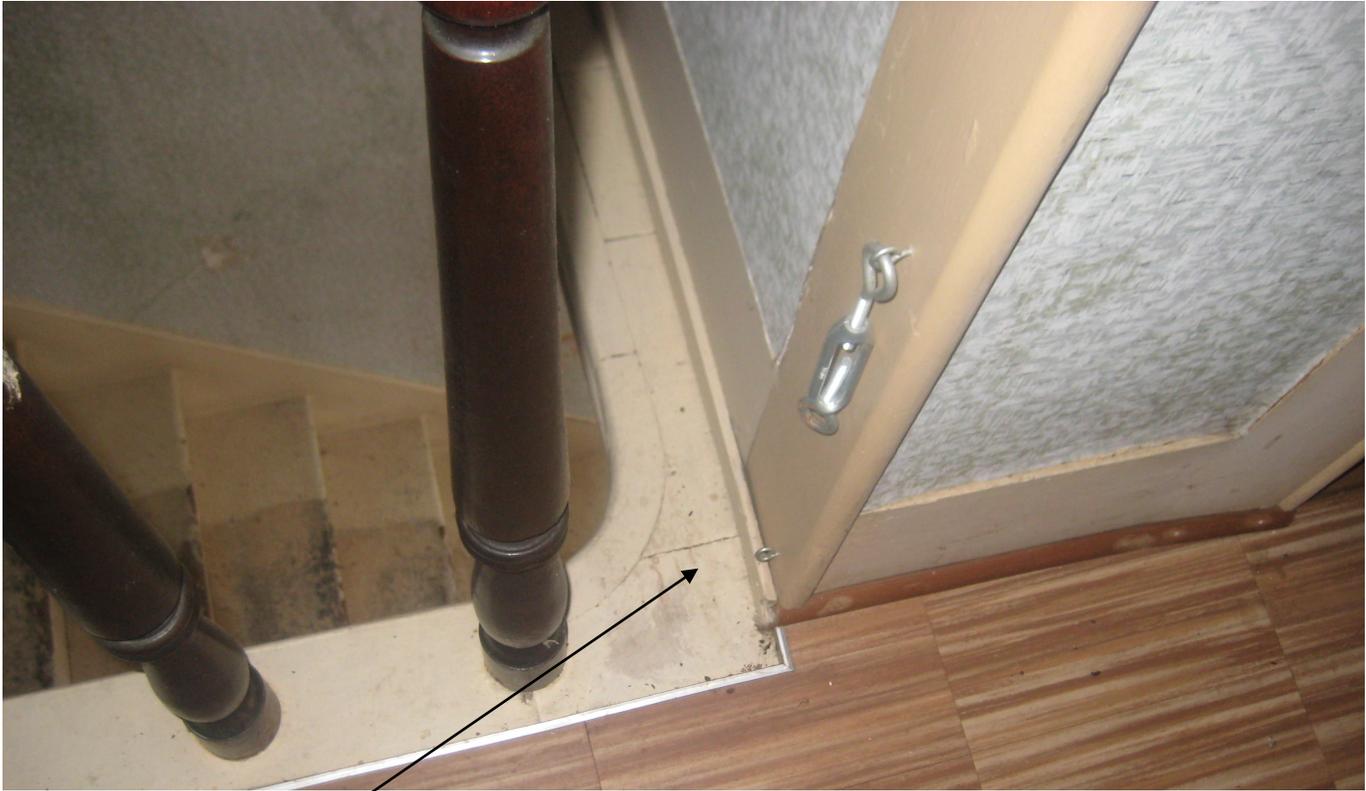
The Second Floor

The floorboards that are exposed on the second floor are consistent with those found in mid-19th Century houses. Wide floor boards of poplar or pine were popular throughout the 19th Century.

By the 1890s, boards would have been more narrow and by the mid-1890s, were often oak.

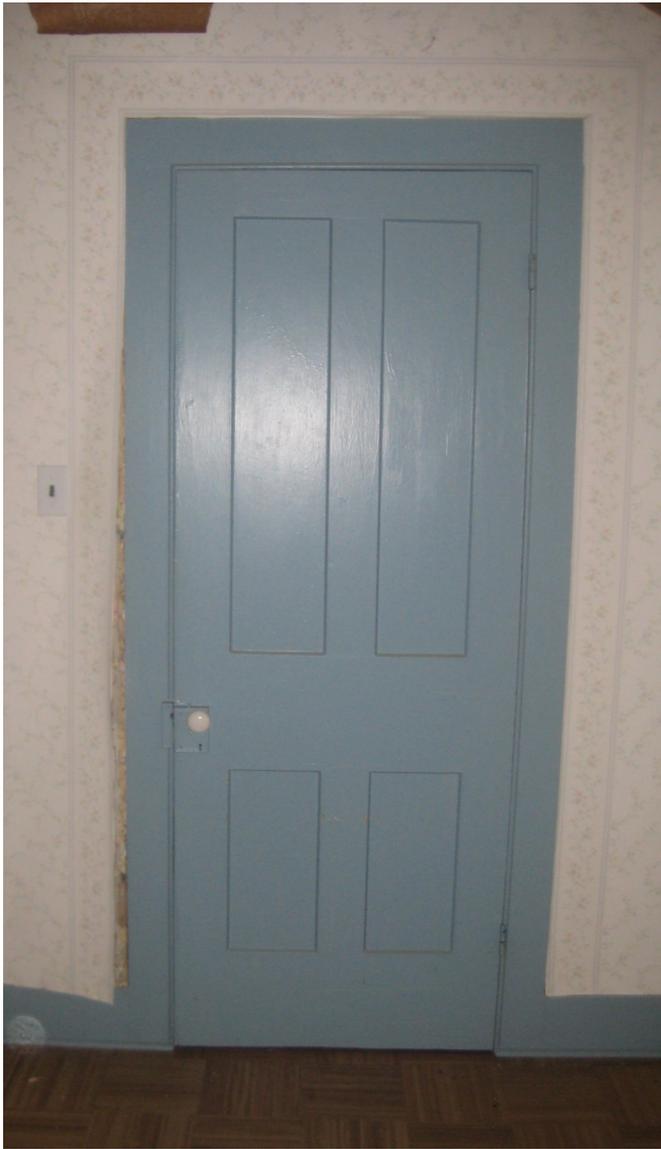
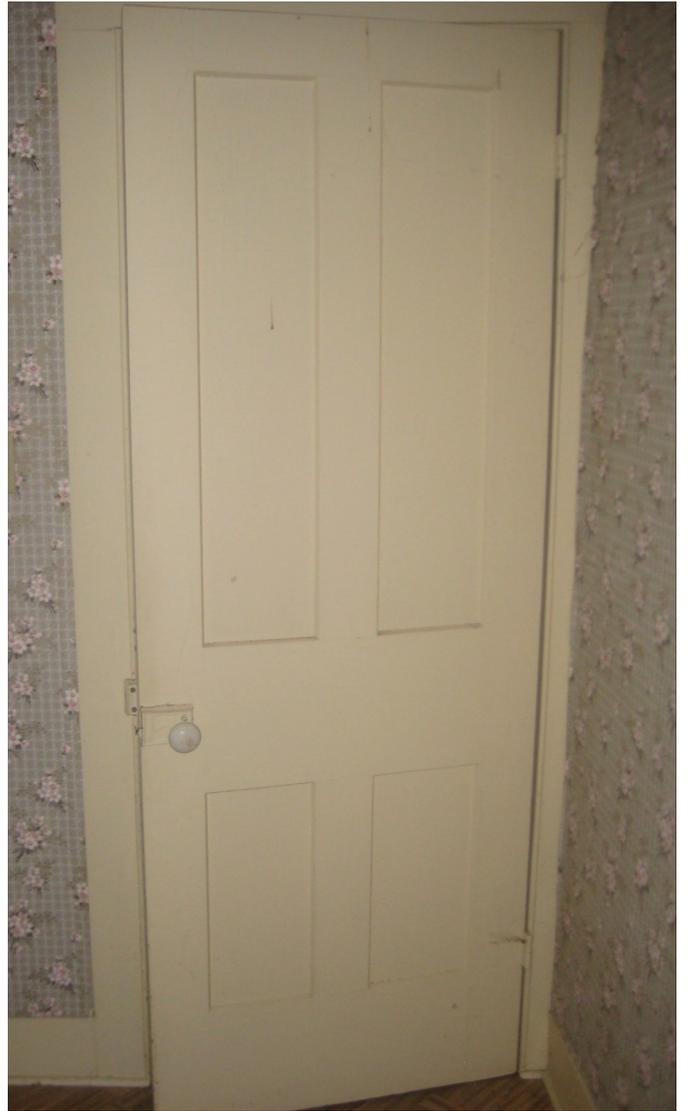
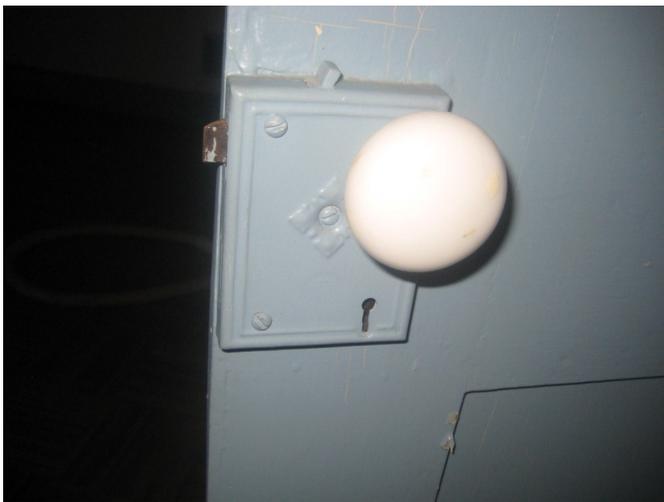
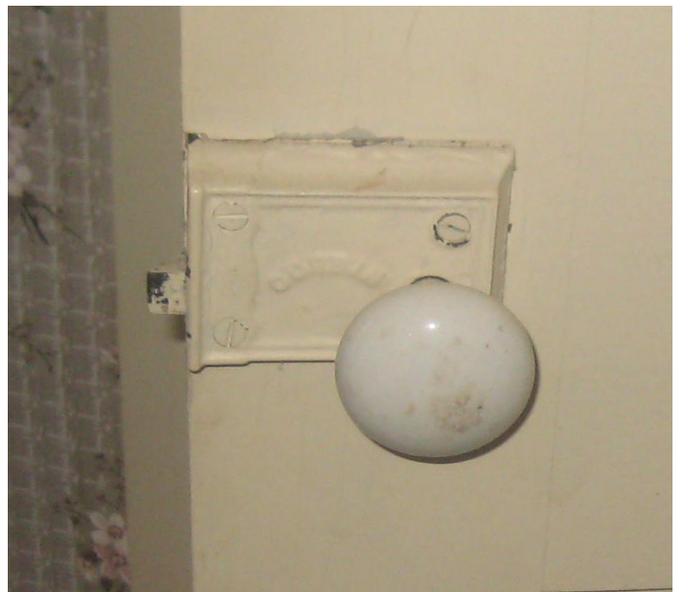
Other than the floor covering, there has been little alteration to the Second floor in one hundred and fifty years. The simple paneled doors are mid-19th Century. Many of these doors still have original early Victorian hardware.

Rim locks are surface mounted iron boxes that were popular from about 1840 until the early 20th Century. These locks help refine the date of construction of the Knopp House. Had the house been built prior to 1840, these doors would have likely had what are known as Norfolk latches. From about 1870 on, most doors had “mortise” locks (which are mortised into the door itself) like those we are accustomed to today. Rim locks continued to be used throughout the 19th and into the early 20th century, especially in rural houses.

The style of the door, however, along with the rim locks, clearly indicate a mid-19th century date of construction.

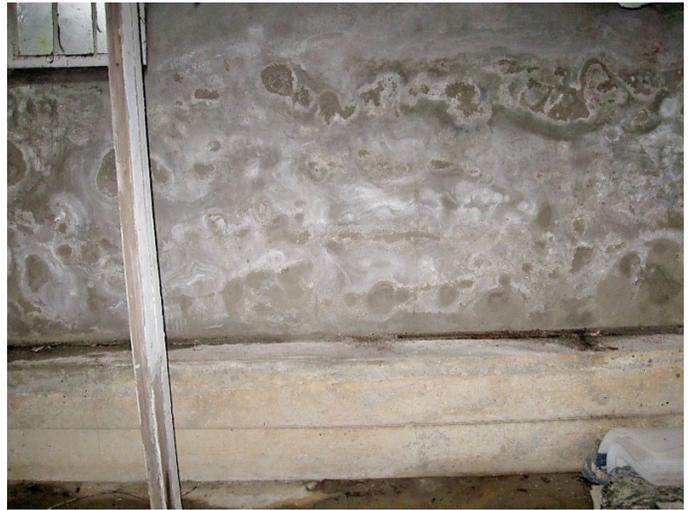
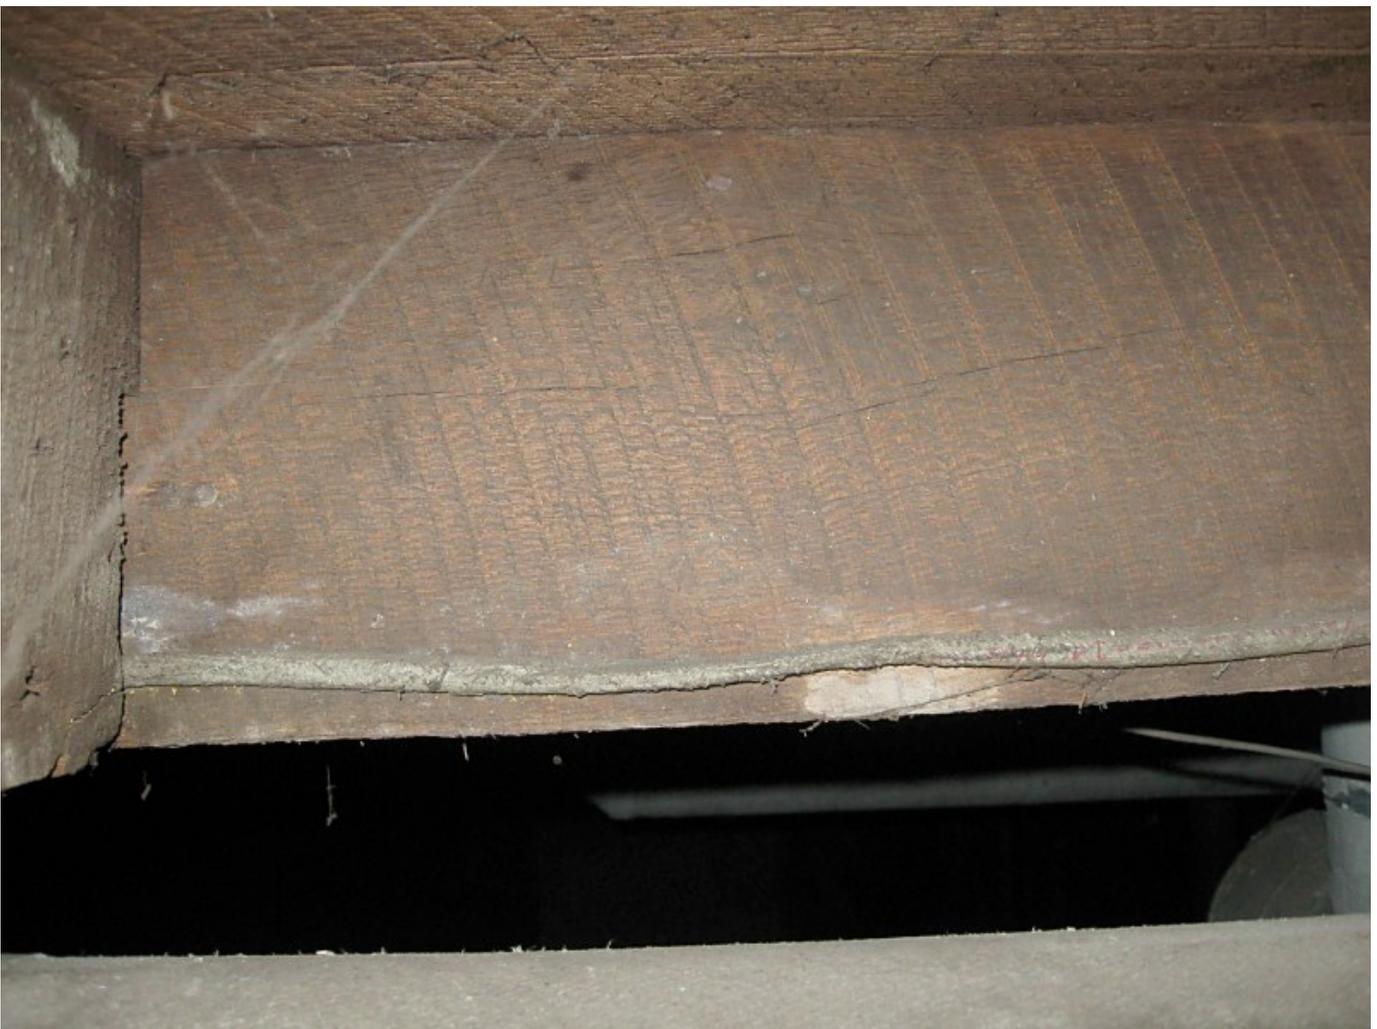
The ledge shows the original and added foundation walls. These hewn beams show circular saw marks, indicating how early the house could have been built rather than how late (after 1840). In the attic, original wood shakes are seen through the roof boards. *These photos courtesy of Jim Fry, The Museum of Western Reserve Farms and Equipment, Richfield Township.*

The basement has seen more change, as the basement was dug at a later date—evidenced by the change in material. Much of the foundation has been parged and is not visible. There are saw marks evident on some of the visible floor joists. The fact that this is not visible and has been changed is unimportant as the evidence is so clear otherwise that this structure dates to the mid-19th century.

Typically, basements are helpful in determining the date of construction of a structure. The basement of the Knopp house has seen much change in the last half of the 20th Century, such as parging of the basement walls and covering much of the framing. It is likely this is when this basement was dug (indicated by the change in foundation material and the “ledge” in the basement). There are joists that have visible saw marks. These appear to be circular saw, which came into use in most locations after 1840, again supporting other evidence that the Knopp was constructed between 1840 and 1850.

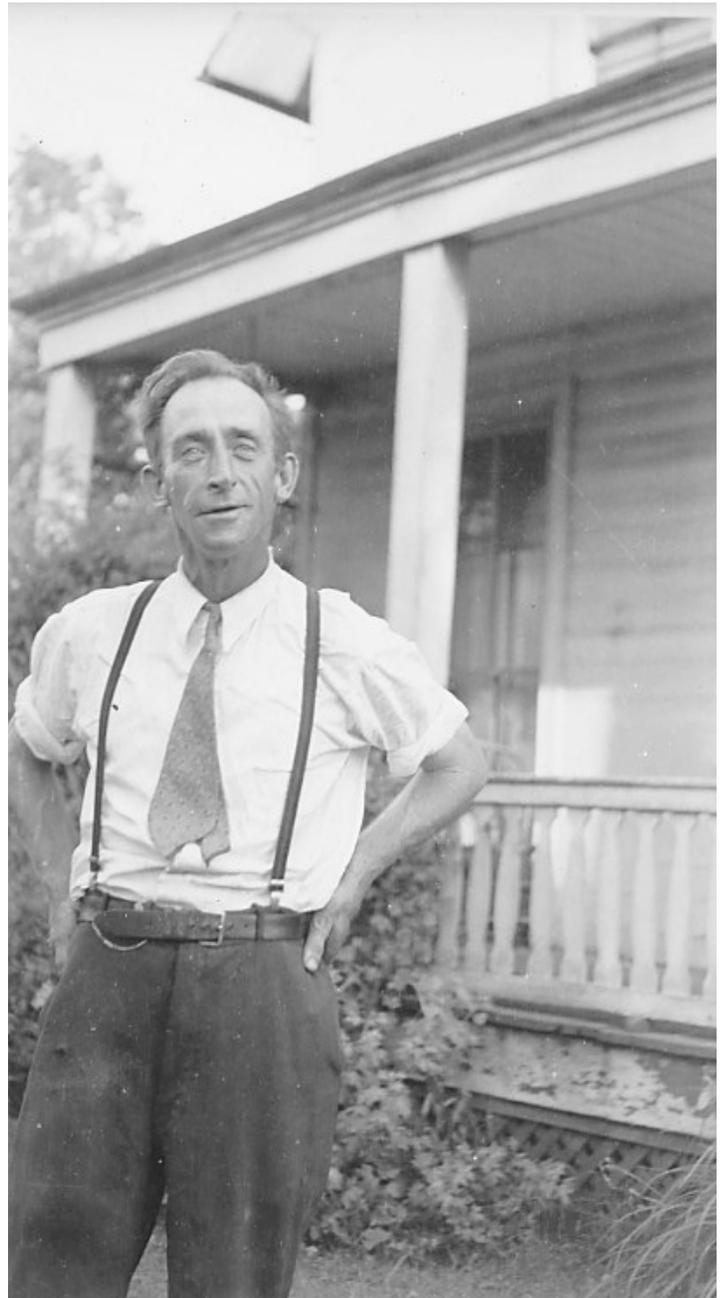
Ray Sapsford by the front porch of the Knopp house. Note that the spindles are sawn rather than turned. Photo undated, courtesy of Jim Fry, The Museum of Western Reserve Farms and Equipment.

Viability—Although the Knopp House obviously needs to be rehabbed to make it viable, there does not appear to be any structural issues with the house. The removal of late 20th century interior finishes, addition of handicapped accessible restrooms and a kitchen or kitchenette, and restoration of remaining mid-19th to early 20th Century finishes would make the Knopp House an attractive location for a commercial, civic, or non-profit use. The exterior restoration should include removal of Insulwood, repair and painting of wood siding and windows, and a new architectural shingle roof that replicates the look of wood shakes. The front porch could be restored using the historic photo as a guide or left as it is today with a canopy (repaired and painted).
